Otane Developments Ltd

GEOTECHNICAL INVESTIGATION REPORT
FOR PROPOSED SUBDIVISION
20737 - 19-29 Russell Street, Otane

Project Reference : 20737
January 13, 2022

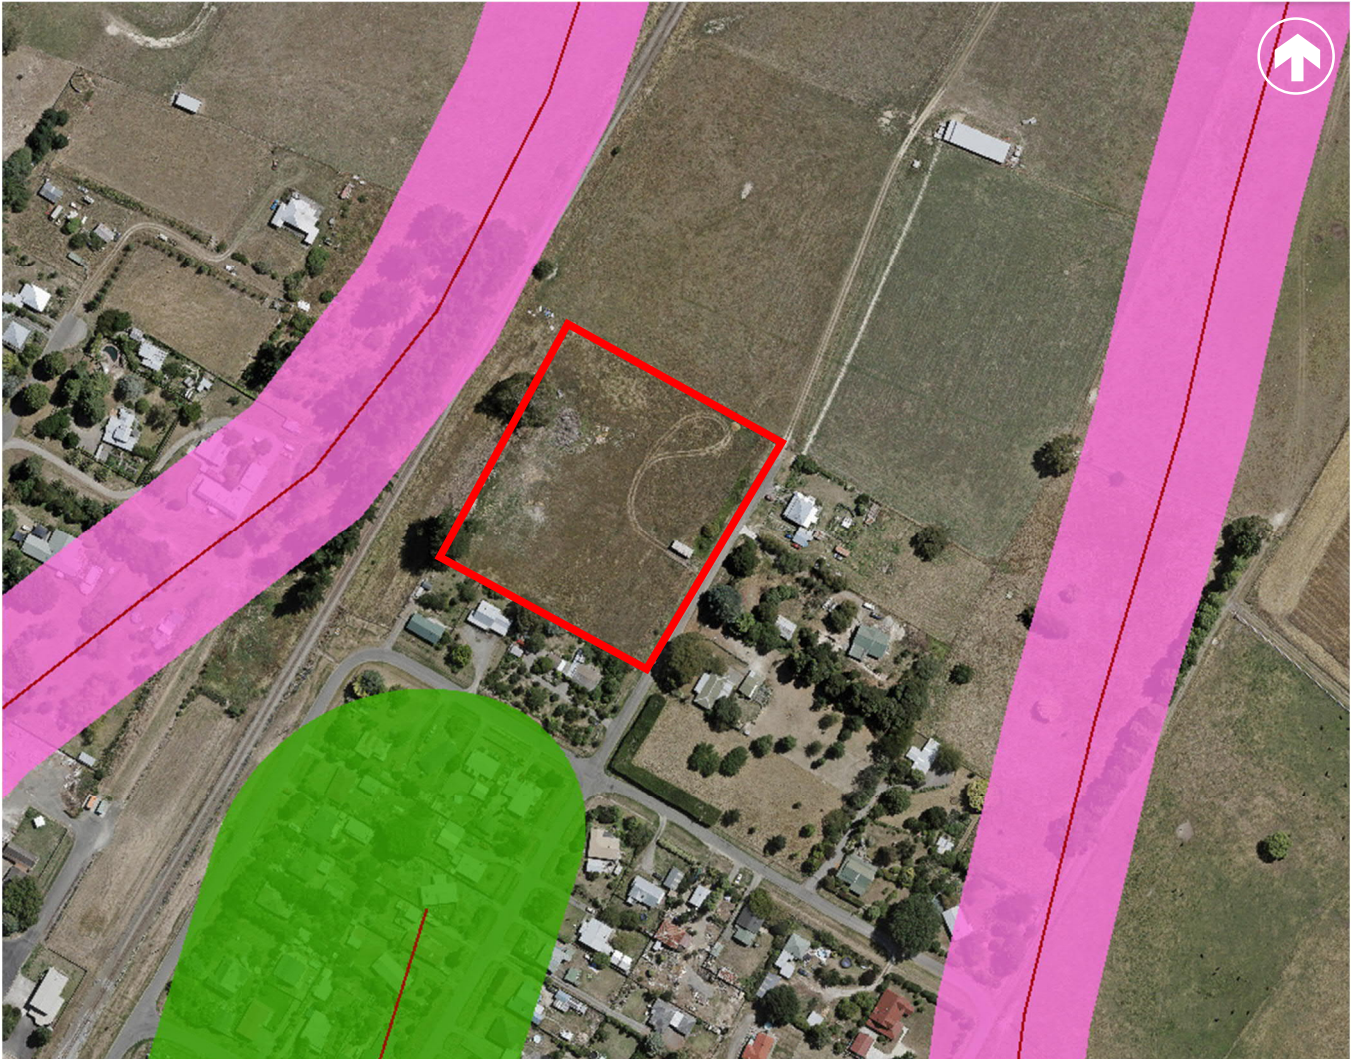
Figure 4: Aerial image showing the mapped faults in the immediate area of the site. The accurately mapped traces are shown in pink, with the distributed fault in green. (Source: Retrolens).

The GNS NZ Geology Webmap and Active Faults Database¹⁰ do not show any faults passing beneath the site, with the nearby GNS mapped Fault Avoidance Zones (HBRC Hazards Portal) not extending across the subject site, although it is noted that a distributed fault terminates just to the south of the site which has a trajectory that would intersect the site if it continued further to the north (Figure 4). There does not however appear to be any surface expressions which would indicate the presence of an active fault line beneath or within close proximity to the site. We therefore consider that the surface fault line rupture risk to be low and that no further detailed trenching assessment is warranted.

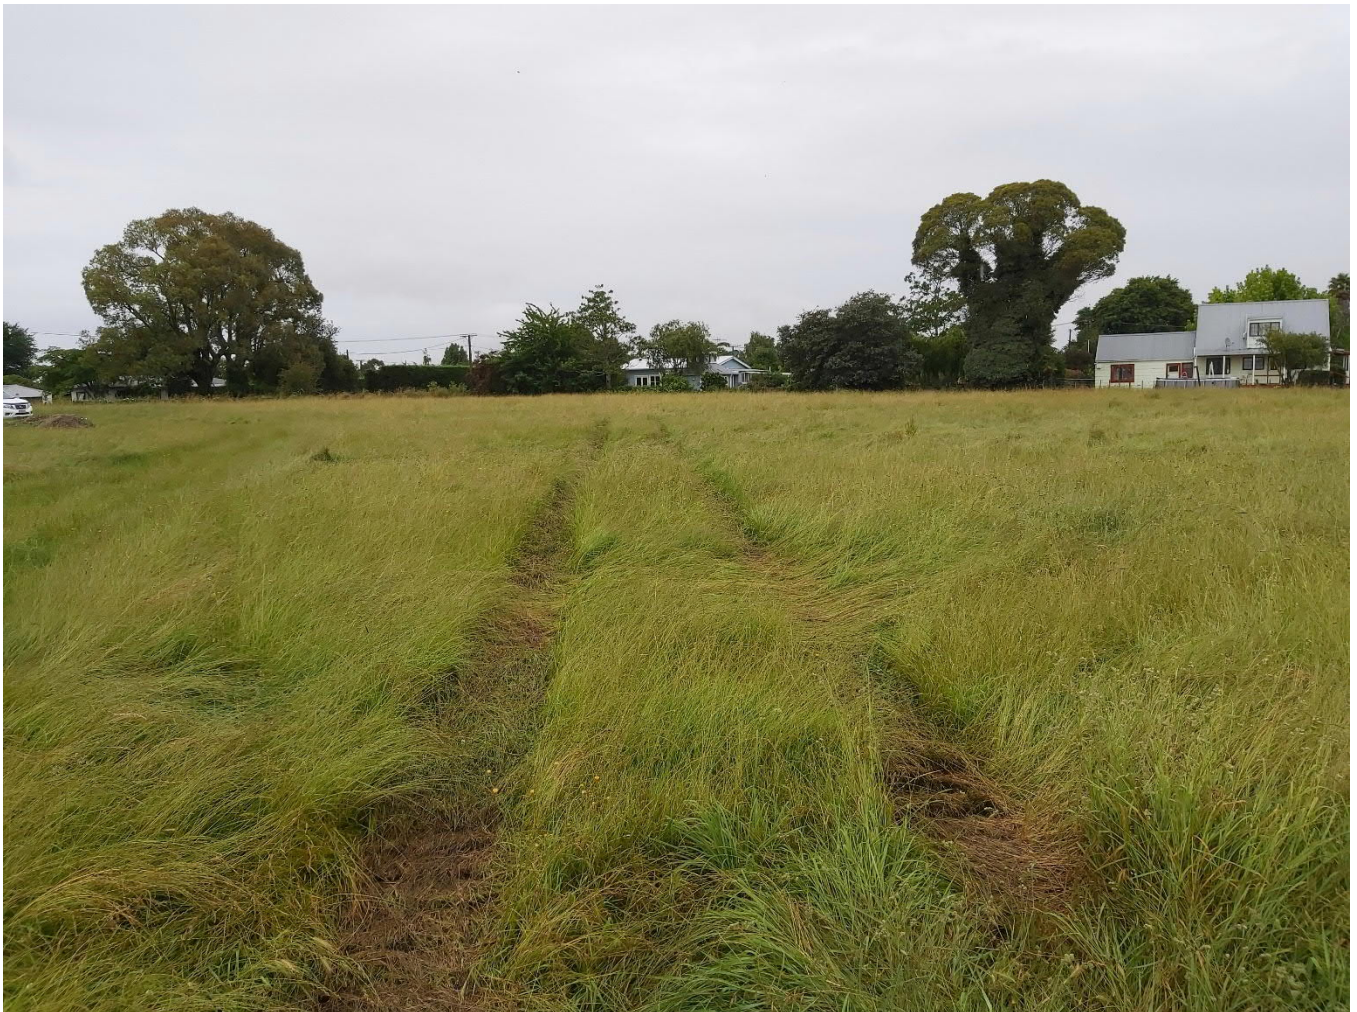
Figure 5: Photo of the site looking south, showing the generally flat nature of the site.

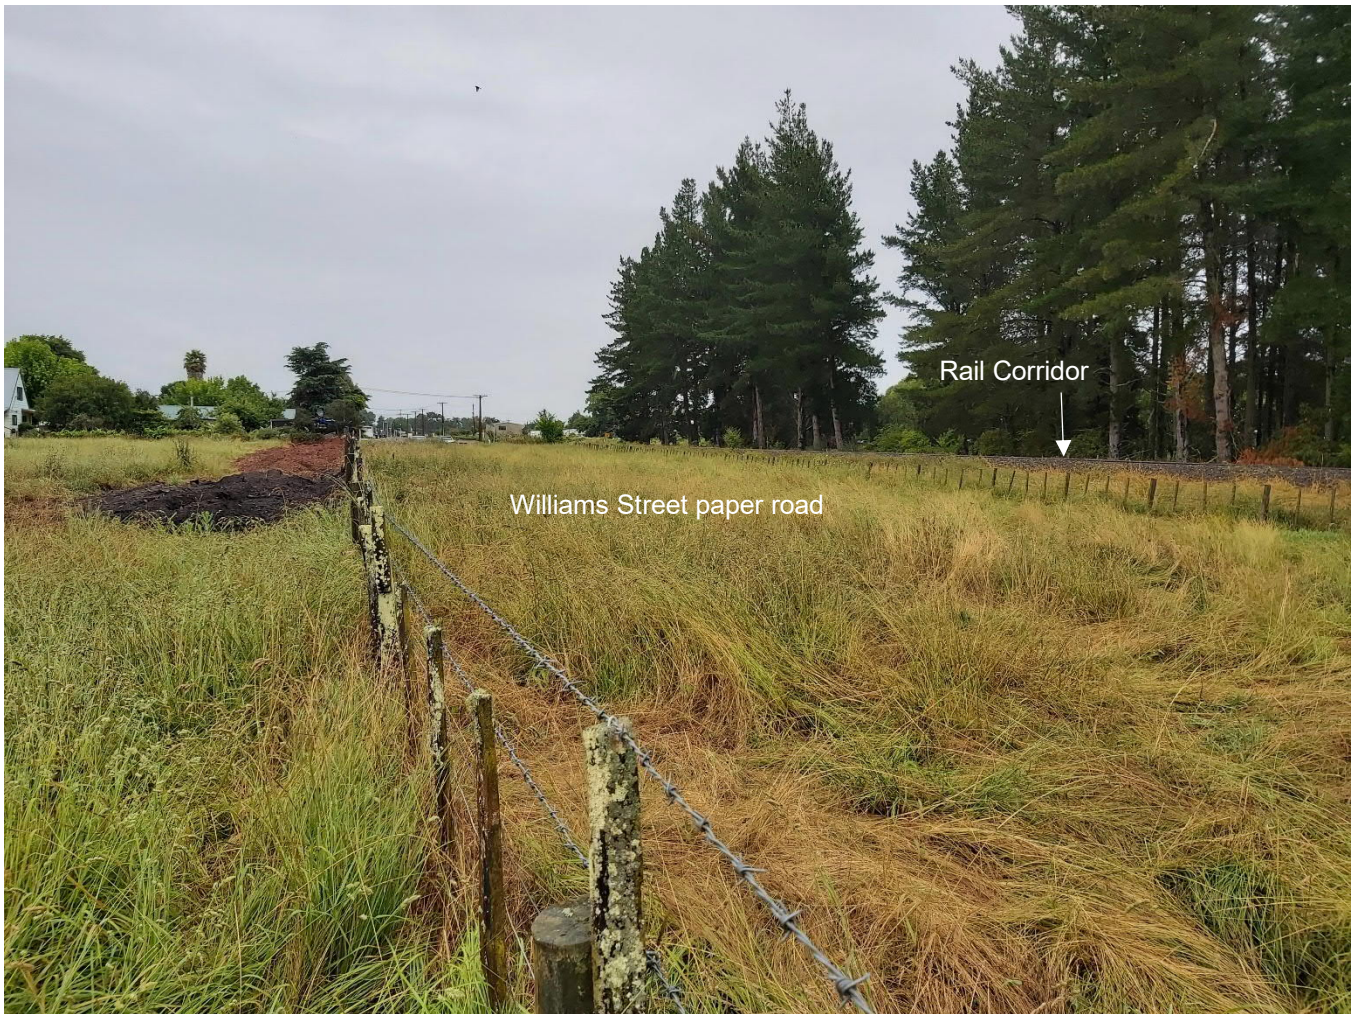
Figure 6: Photo of the western boundary showing the Williams Street paper road and the rail corridor beyond.

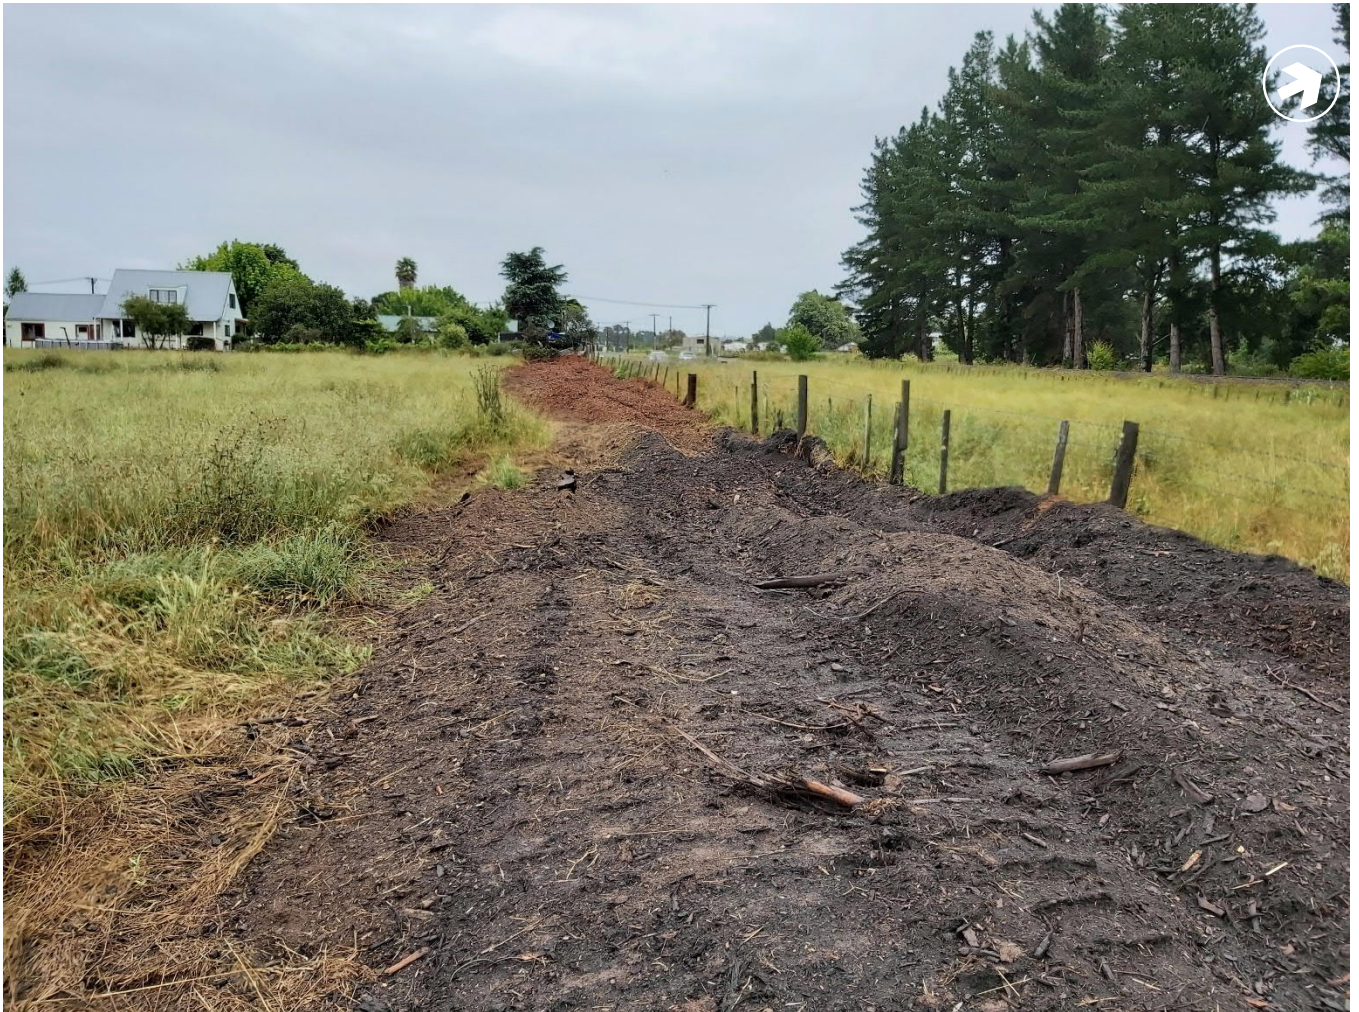
Figure 7: Photo looking along the western boundary showing the woodchips and bark remaining from the trees removed in this area.

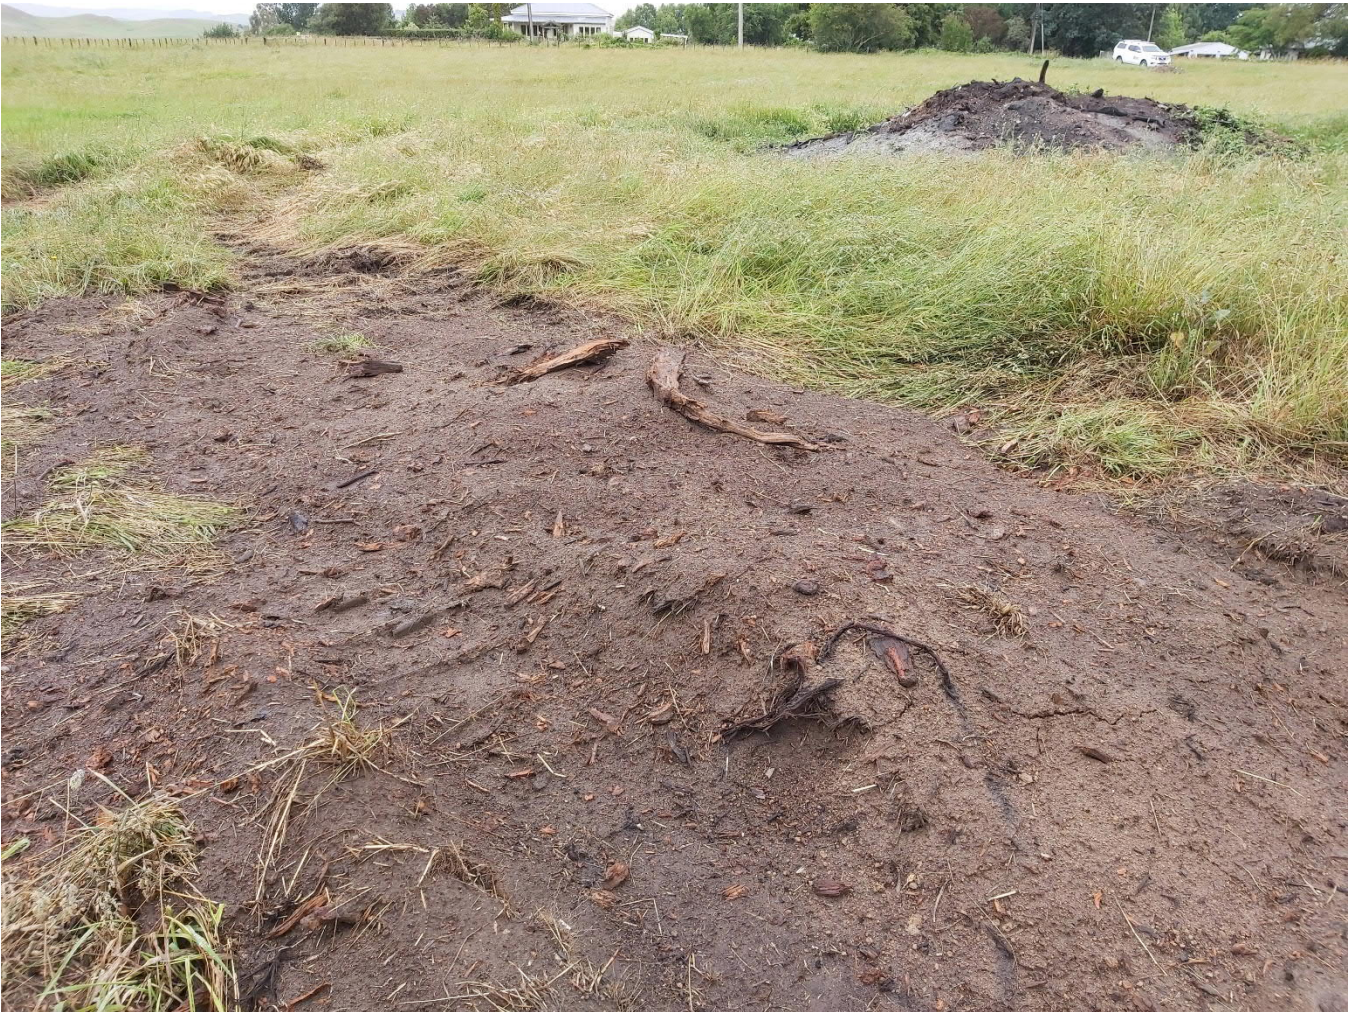
Figure 8: Woodchip pile and burn pile to the west of the site.

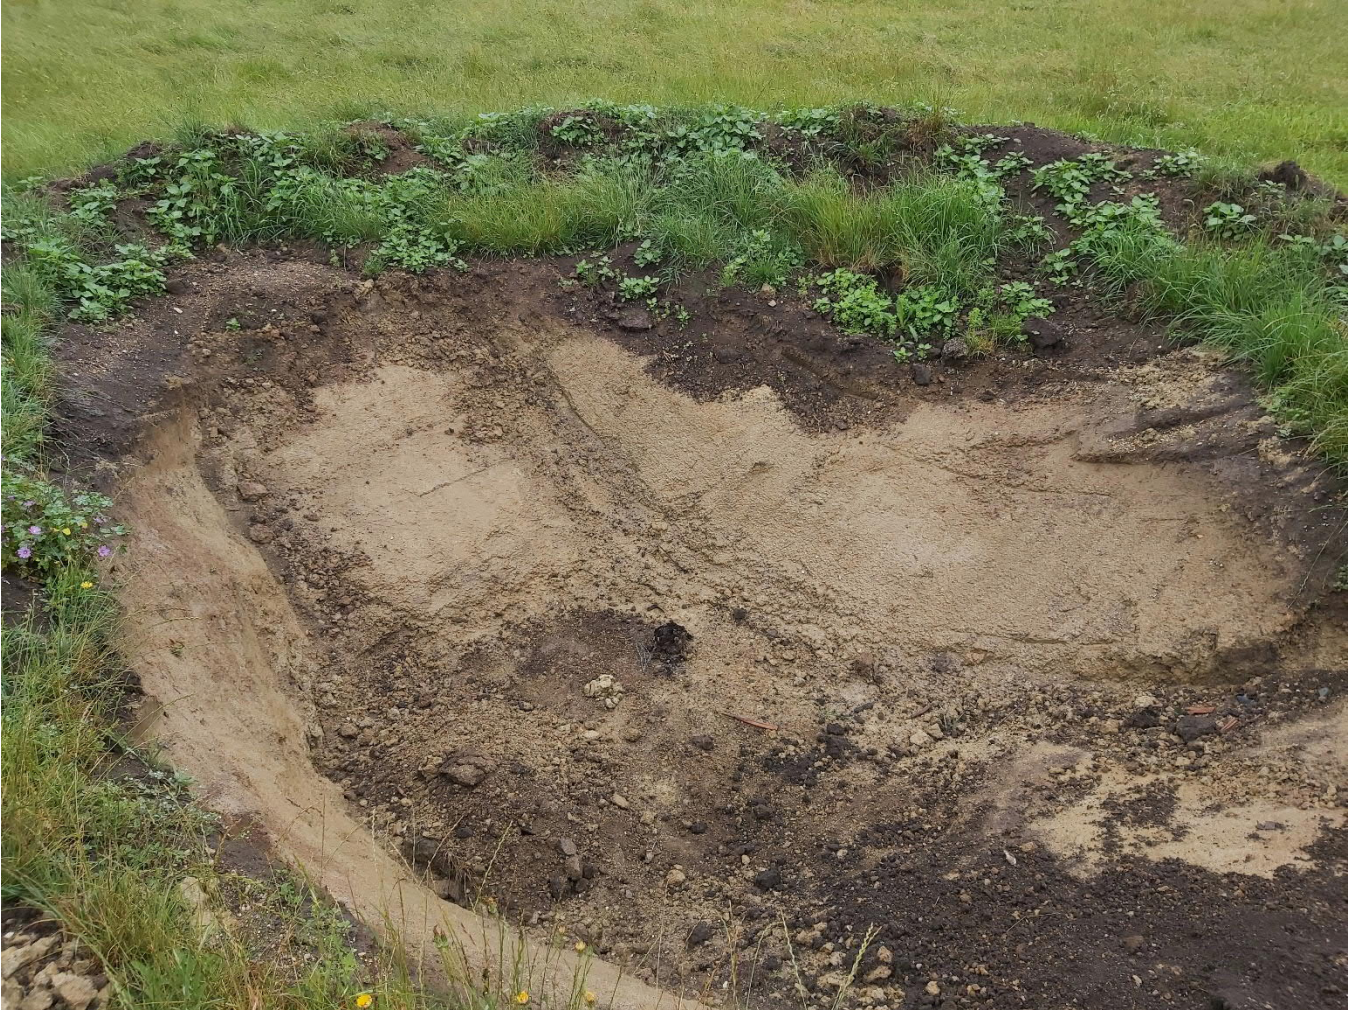
Figure 9: Test pit excavation present during the site investigation, showing the underlying geology of the site.
